BIOLOGICAL DAMAGE OF CULTURAL MONUMENTS IN THE REPUBLIC OF MACEDONIA

Abstract

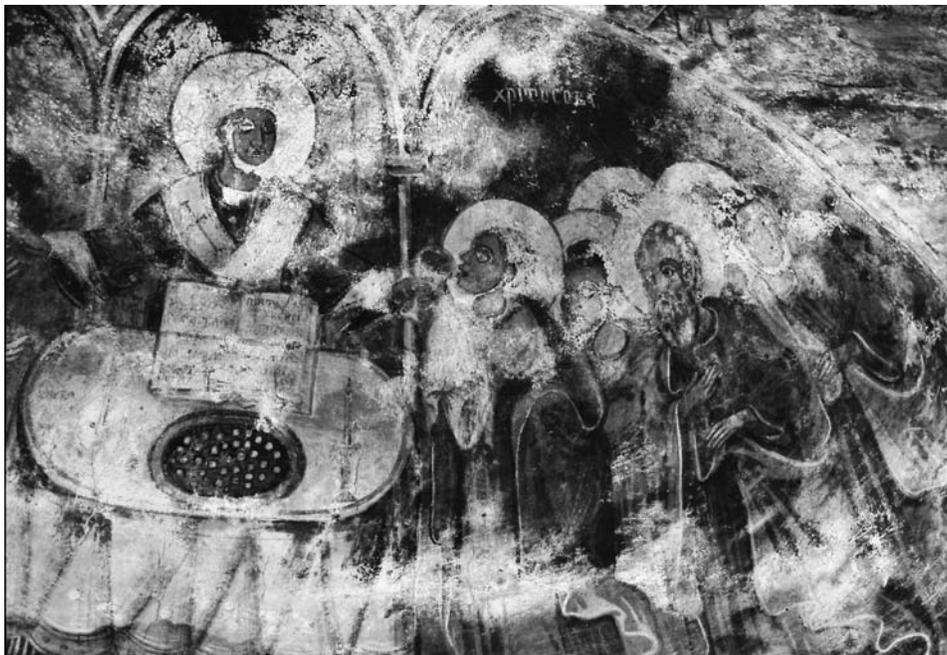
The diagnosis of biological damage indicated that the frescoes in some places were extensively attacked by black-mould colonies identified as *Cladosporium* sp. (Fig. 2). The old attack by Anobiidae insects was found on the wooden icons and iconostases, the bookend, the stairs to the pulpit, and the doors.

Fig. 2. Frescoes with black-mould colonies of *Cladosporium* sp.

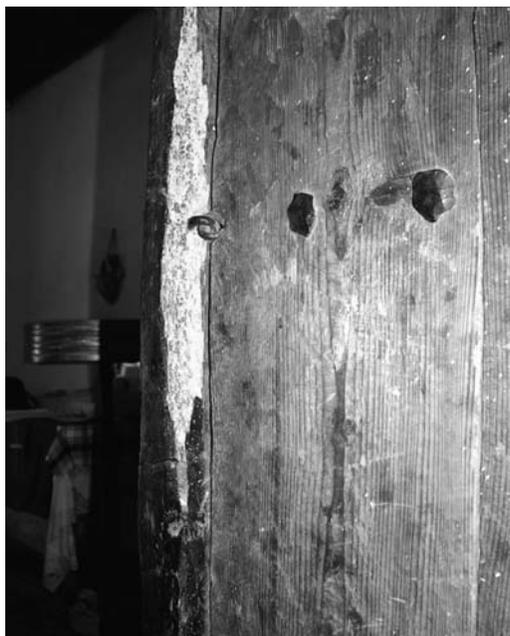
The diagnosis of biological damage revealed that the construction inside the church was attacked both by fungi and insects. An old attack of Anobiidae insects was found on the wooden details of the iconostases (*Abies alba* L.); fresh insect damage (small holes and white frass) was found on the inner door (Fig. 3). Fruit bodies of the corticoid fungus *Hyphodontia aspera* (Fr.) J. Erikss. were found on the same door. The frescoes in some places were attacked by black-mould colonies identified as *Aspergillus* sp.

Fig. 3. Inner door with fresh damage of Anobiidae insects.

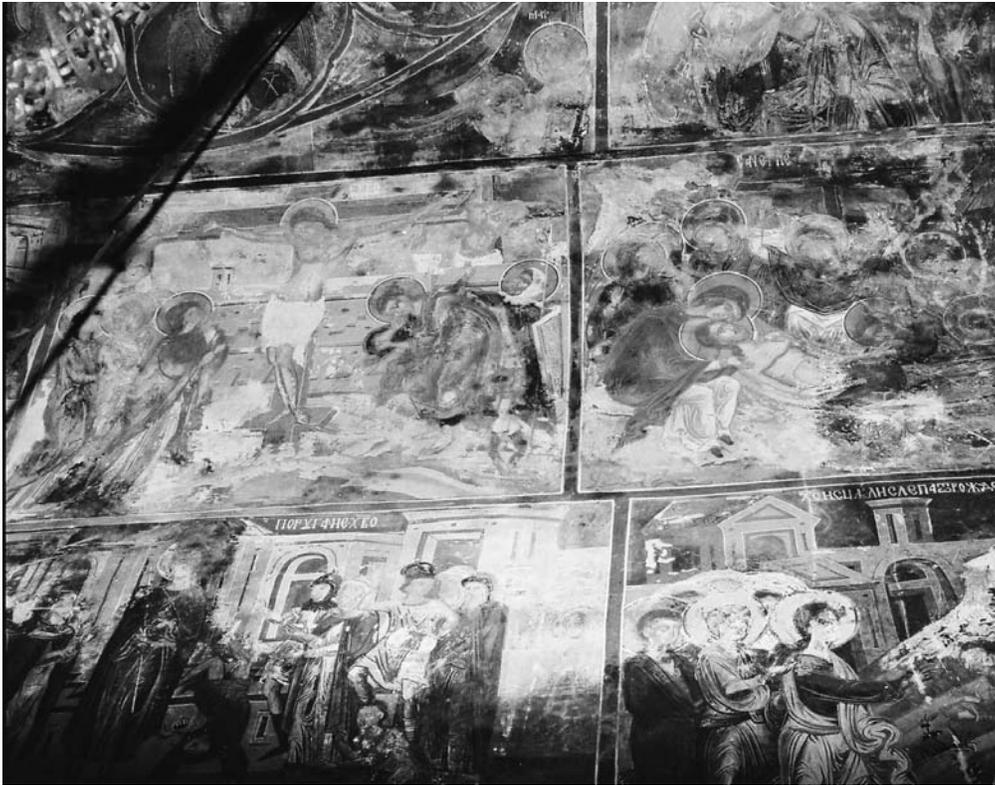
Frescoes were restored between 1980 and 1987 and a few colonies of moulds were recorded on the extracted material. They were identified as: *Aspergillus* sp., *Cladosporium* sp. and *Fusarium* sp (Fig. 4.).

Fig. 4. Frescoes with mould colonies

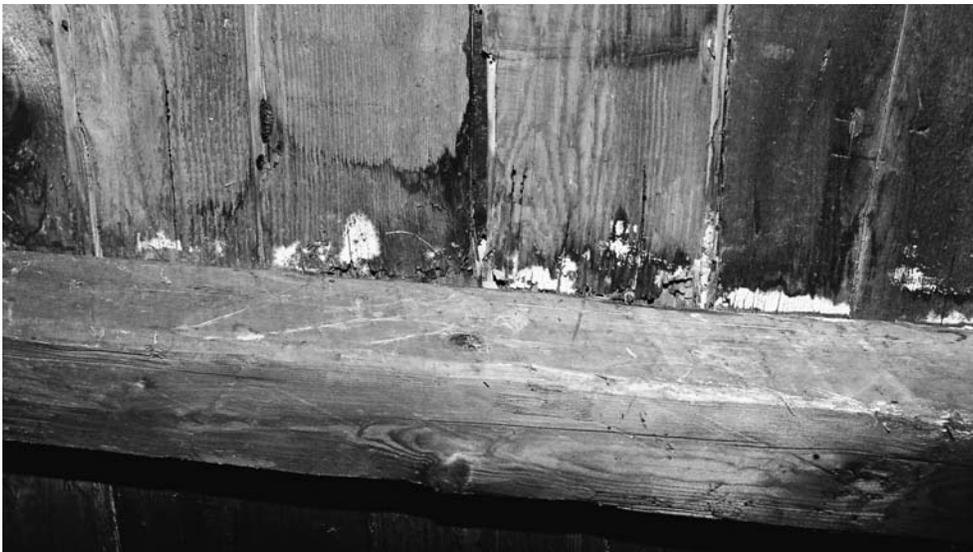
The diagnosis of biological damage indicated that the construction in the interior was attacked by decay fungi. The wooden beams in the ceiling were heavily biodegraded. From the outside, the beams were sound, but inside they were empty, completely destroyed by *Antrrodia sinuosa* (Fr.: Fr.) Karst. The walls with frescoes were dry and no moulds were noticed. The wooden roof of the outside room was damaged

by a decay fungus, *Athelia decipiens* (Höhn. & Litsch.) J. Erikss. (Fig. 5).

Fig. 5. The wooden roof of the outside room damaged by *Athelia decipiens*.

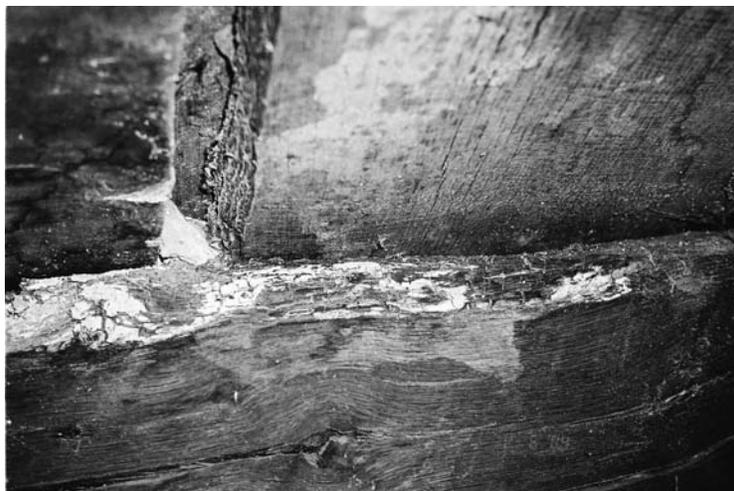
Outside, the stairs on the bell tower were damaged by fungi and insects. Two corticoid species, *Hyphoderma praetermissum* (P. Karst.) J. Erikss. & Å. Strid. and *Hyphodontia crustosa* (Pers.) Erikss were identified, and an old attack of Anobiidae was found. On the bell tower roof construction, fungal damage of the corticoid species *Hyphodontia crustosa* (Pers.) Erikss was found (Fig. 6).

Fig. 6. Roof construction attacked by *Hyphodontia crustosa*.

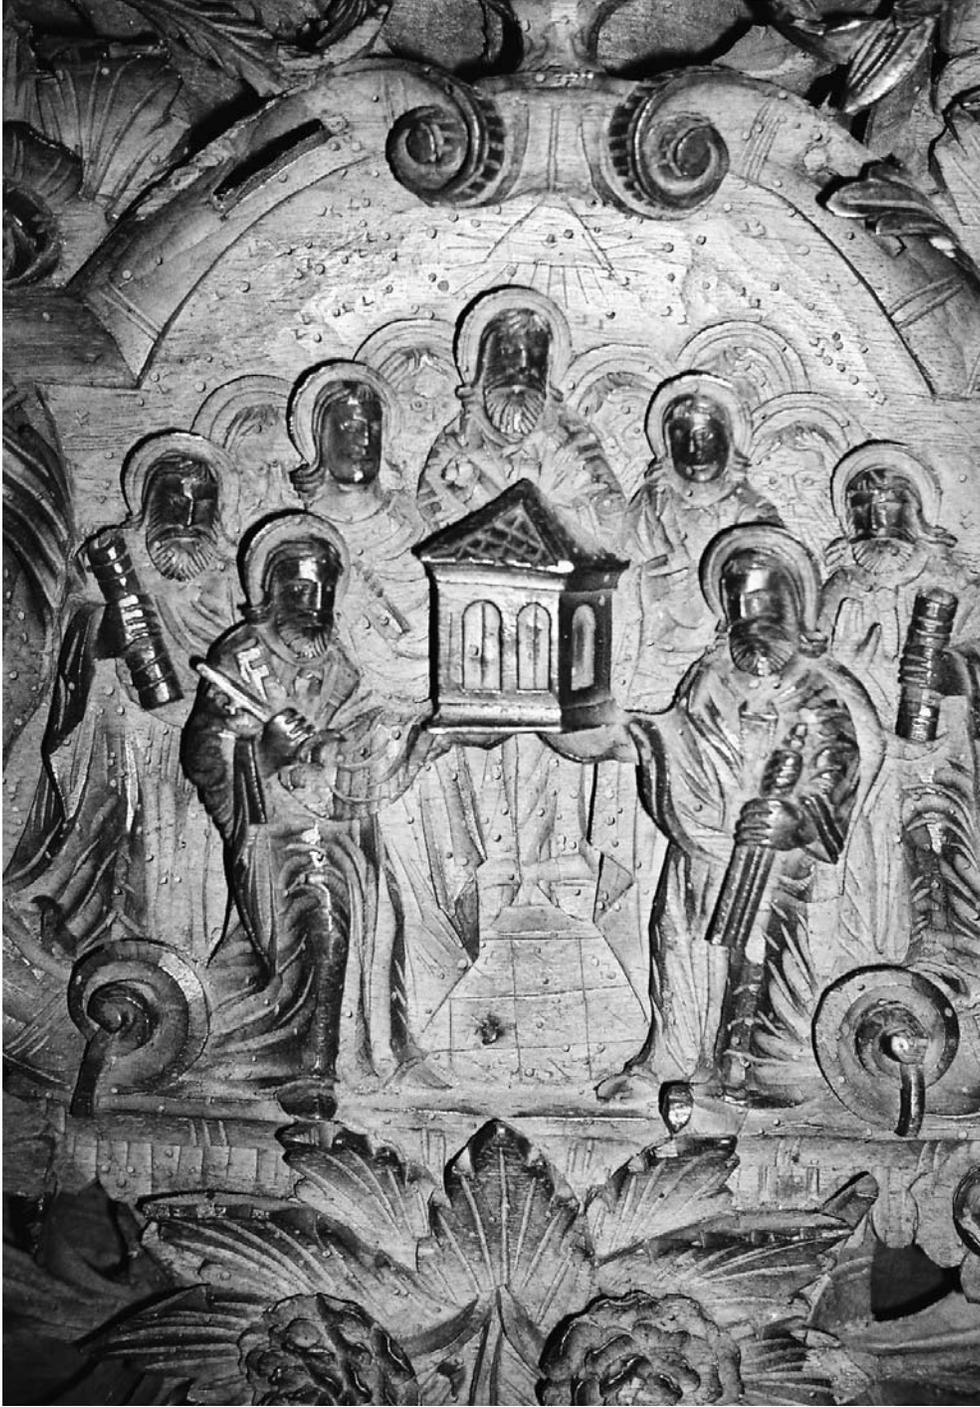
The diagnosis of biological damage showed that the construction inside the church was dry and no fungal attack was noted. No mould contamination was visible on the frescoes. Only an old attack of Anobiidae insects was found on the basis of wood-carved (*Juglans regia*) iconostasis (Fig. 7).

Fig. 7. Old attack of Anobiidae insects on wood-carved iconostasis.
